**2005 Operations, Maintenance,
and Monitoring Report**

Sabine Structure Replacement

State Project Number CS-23
Priority Project List 3

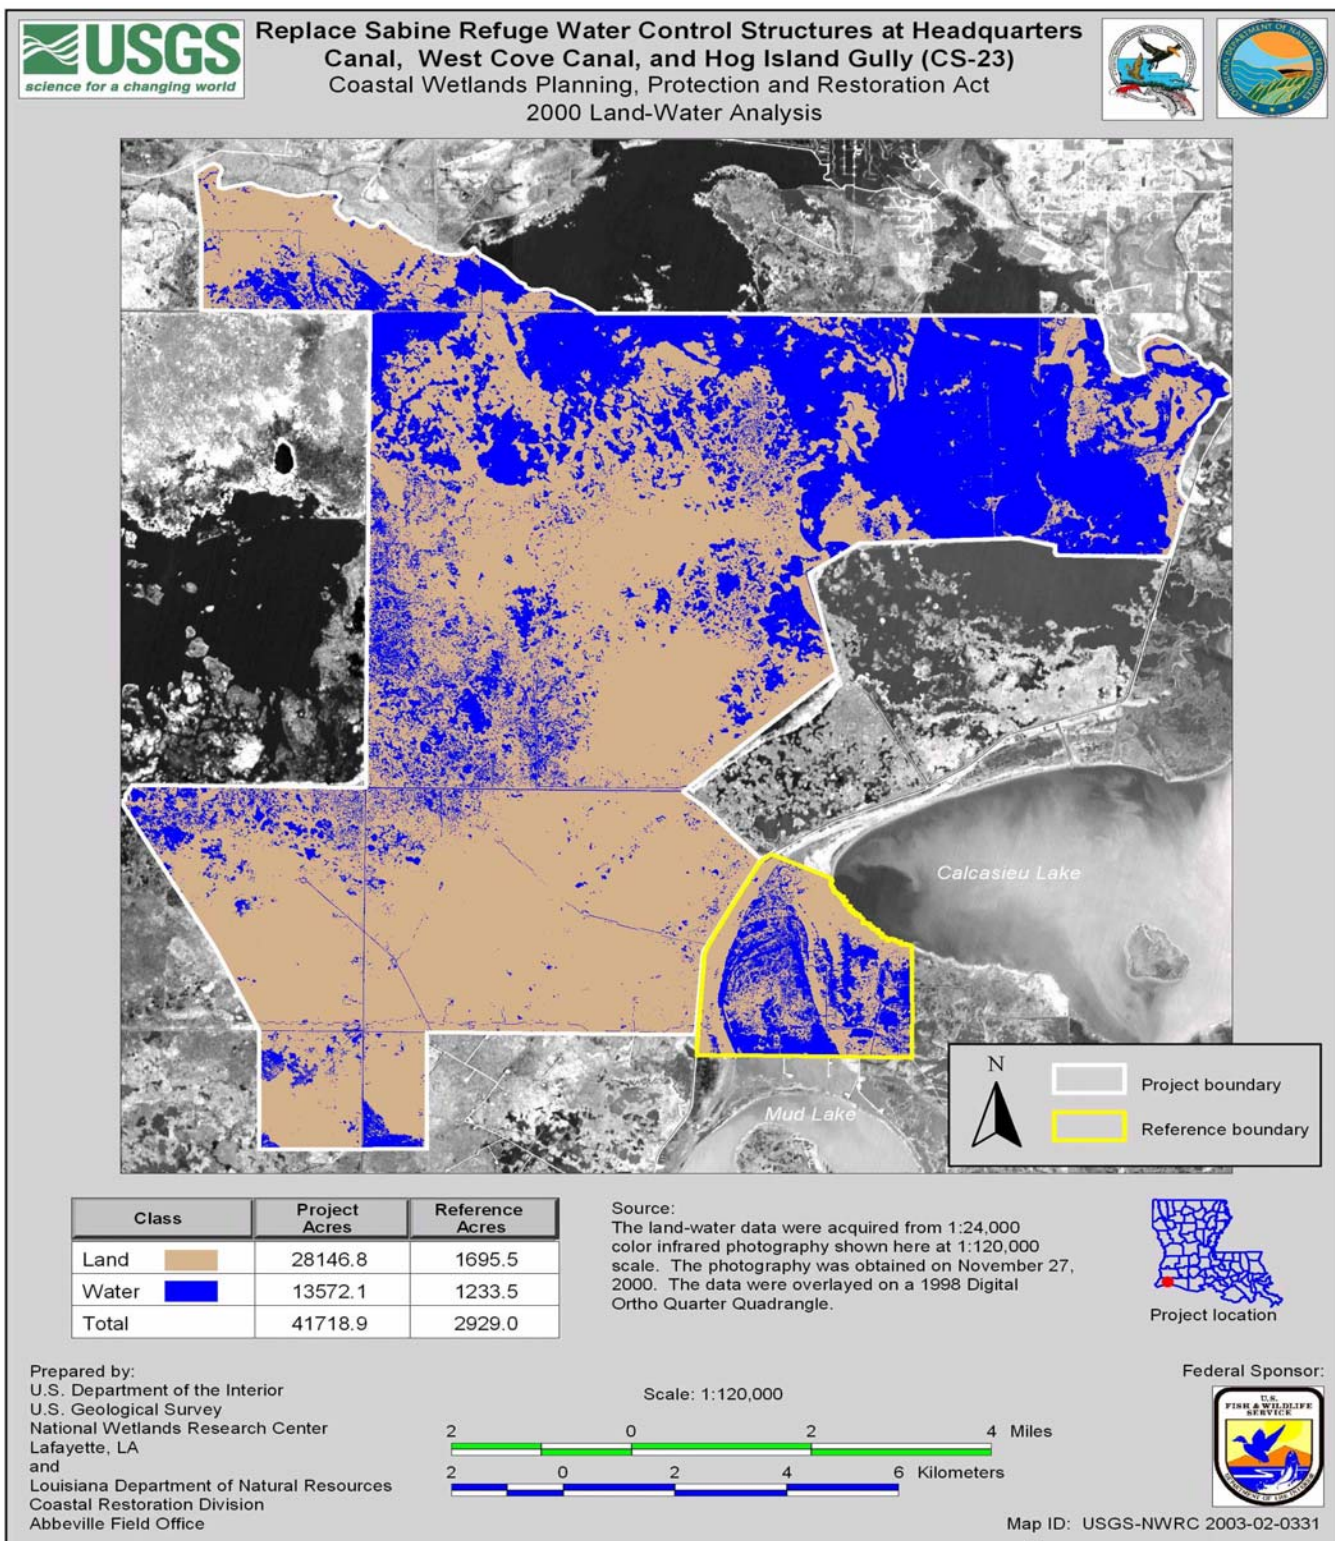
Figure 2. Land/water analysis of the Sabine Structure Replacement (CS-23) project for the project and reference areas from photography obtained November 27, 2000.

Near-vertical color-infrared aerial photography (1:24,000 scale) was used to measure land to water ratios for the project and reference areas (figure 2). The photography was obtained in November 2000 prior to project construction and post-construction in 2004. The original photography was checked for flight accuracy, color correctness, and clarity, and was subsequently archived. Aerial photography was scanned, mosaicked, and georectified by U.S. Geological Survey/National Wetlands Research Center (USGS/NWRC) personnel according to standard operating procedures (Steyer et al. 1995, revised 2000), (figure 3). The photography will be obtained after construction in 2009, and 2018.

Aerial photography was acquired in November 2000 for a land:water analysis (figure 2). Results indicate that the project area had a ratio of 67.5% land to 32.5% water, while the reference area consisted of 57.9% land to 42.1% water. Post-construction photography was collected in 2004 and is currently being processed.

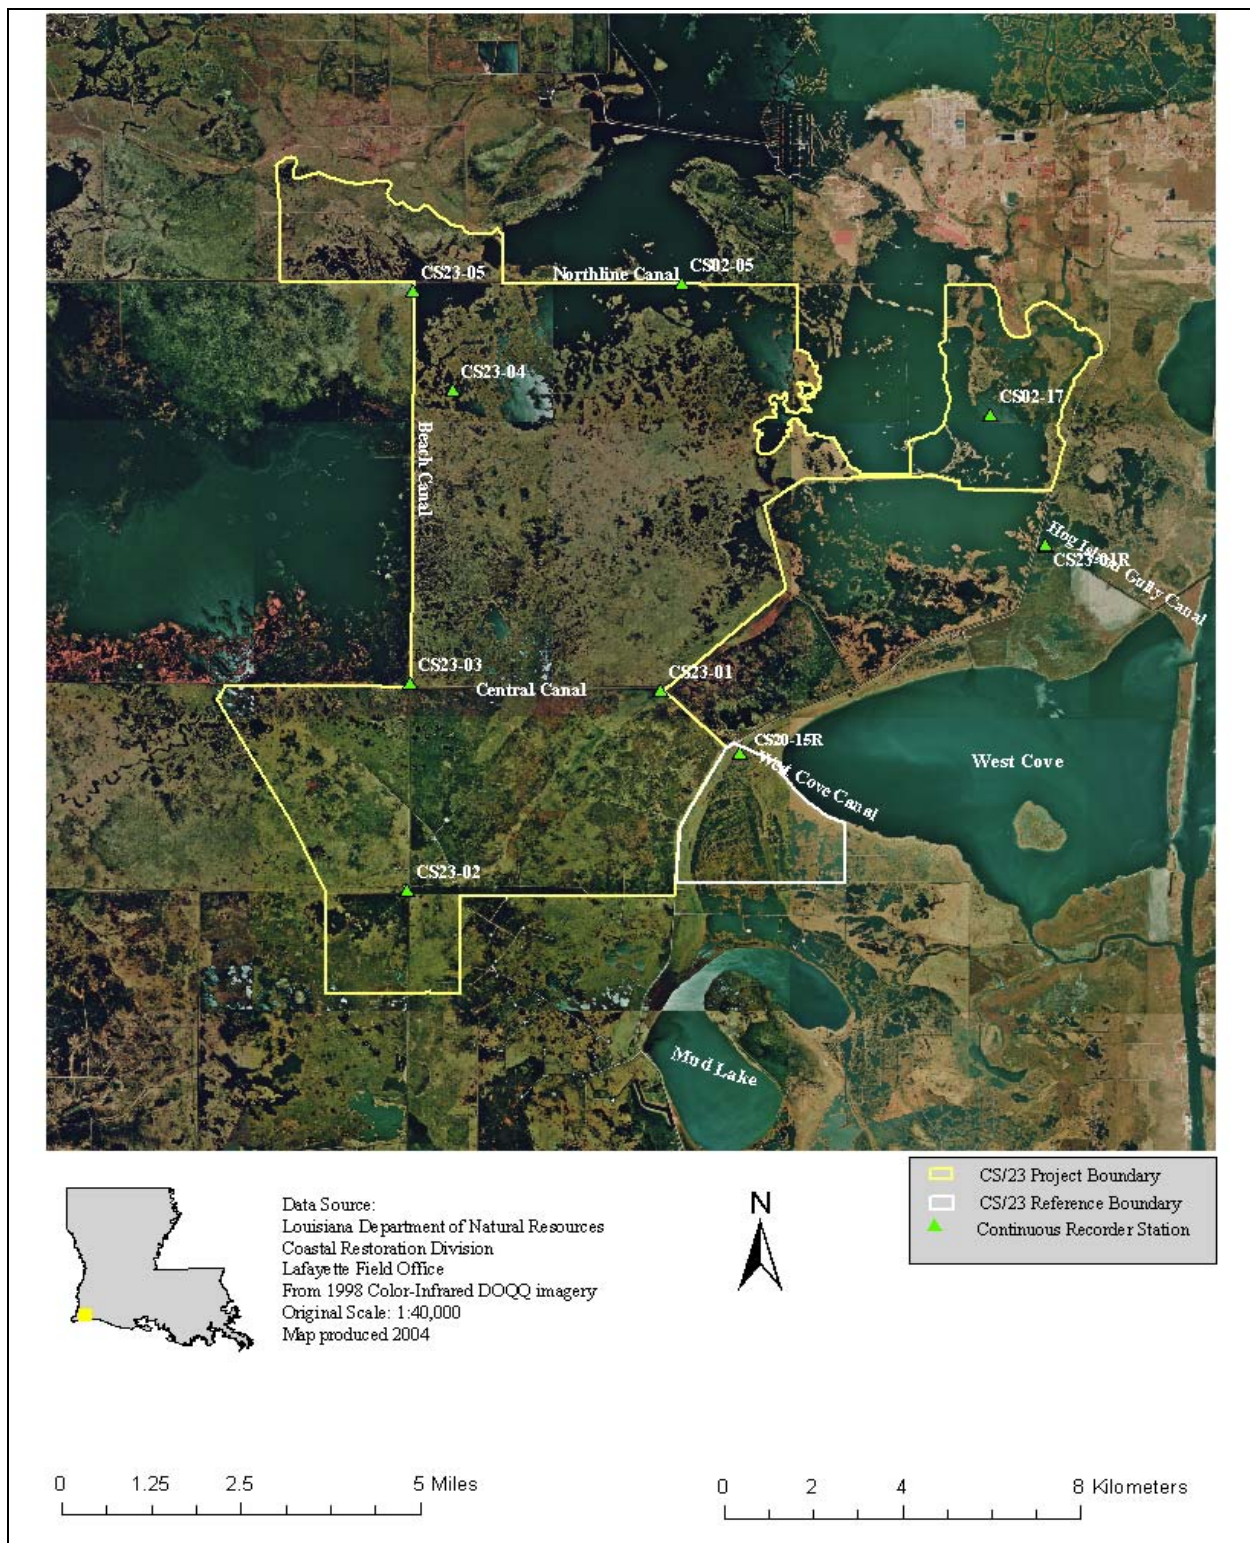
Figure 4. 1998 DOQQ imagery of continuous recorder monitoring stations in the Sabine Structure Replacement project and reference areas.

Salinities were monitored hourly utilizing eight continuous recorders (figure 4). Six are located in the project area, one in the reference area, and one outside of the project area within Hog Island Gully Canal. Five recorders are associated with this project, two associated with Rycade Canal (CS02-05, CS02-17) and one from East Mud Lake (CS20-15R). Discrete salinities are collected bi-weekly at 15 stations in the project and reference areas by the U.S. Fish and Wildlife Service (USFWS) and data are provided to LDNR each month. The USFWS has also been collecting salinity, water temperature, dissolved oxygen, pH, and specific conductivity parameters at area stations approximately every two weeks for over 15 years and will continue to do so after project completion. Both discrete and continuous data will be used to characterize

Water levels are monitored hourly utilizing eight continuous recorders (figure 4). Six are located in the project area, one in the reference area, and one outside of the project area within Hog Island Gully Canal. Five recorders are associated with this project, two associated with Rycade Canal (CS02-05, CS02-17) and one from East Mud Lake (CS20-15R). To document annual duration and frequency of flooding, water levels were analyzed at four of the continuous recorder stations, which were referenced to marsh elevations. A staff gauge has been surveyed adjacent to each continuous recorder to correlate water levels to a known datum. Marsh elevations have been established at stations CS23-03, CS23-05, CS02-05, and CS02-17, and will be used to analyze duration and frequency of flooding events. Water levels were monitored in 1998-1999 (pre-construction) and January 1-November 26, 2004 (post-construction) at stations CS23-03, CS23-05, CS02-05, CS02-17, and CS23-01R. Due to the impending installation of Coastwide Reference Monitoring Stations (CRMS), data collection at two of the continuous recorder monitoring stations (CS23-01 and CS23-02) was discontinued in May 2004. The remaining four continuous recorder monitoring stations (CS23-03, CS23-05, CS23-01R, CS02-05) will continue data collection and will be operated by the USFWS. There are 10 CRMS-*Wetlands* stations in the project area.

Salinity data were collected hourly at seven stations (figure 4) associated within the CS-23 project and reference areas (figures 5 to 11).

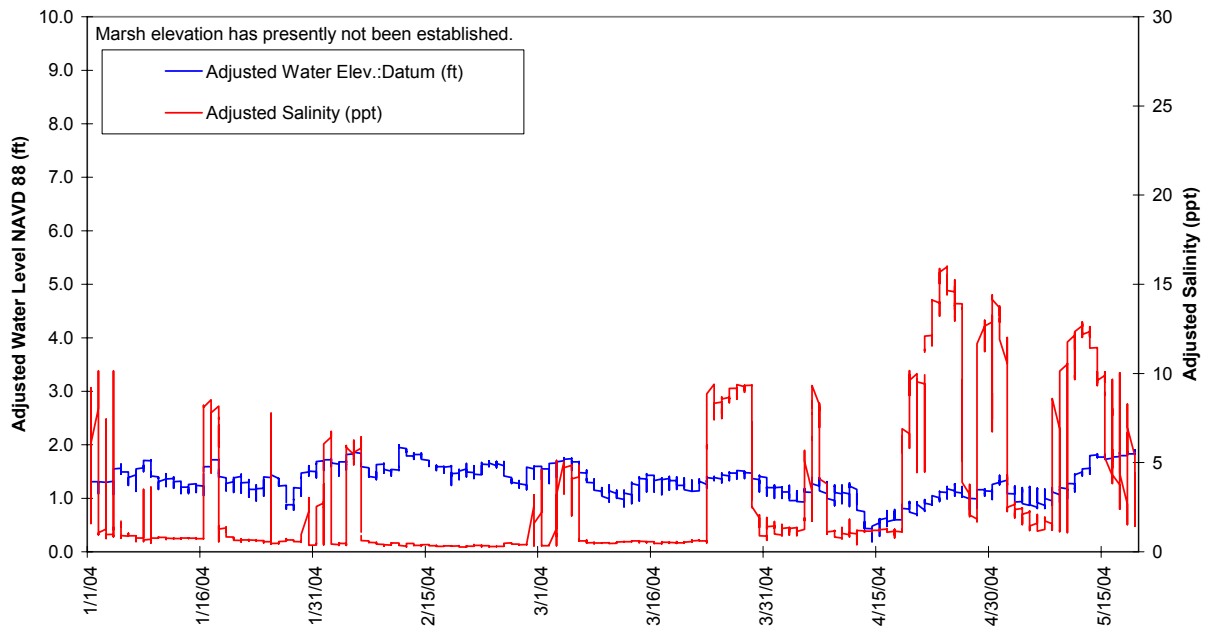
Station CS23-01 (1/1/04 – 05/19/04)
Salinity and Water Level Data

Figure 5. Hourly salinity and water level at station CS23-01 in the Sabine Structure Replacement (CS-23) project area. No marsh elevation was established due to the close proximity of a ridge and shell road.

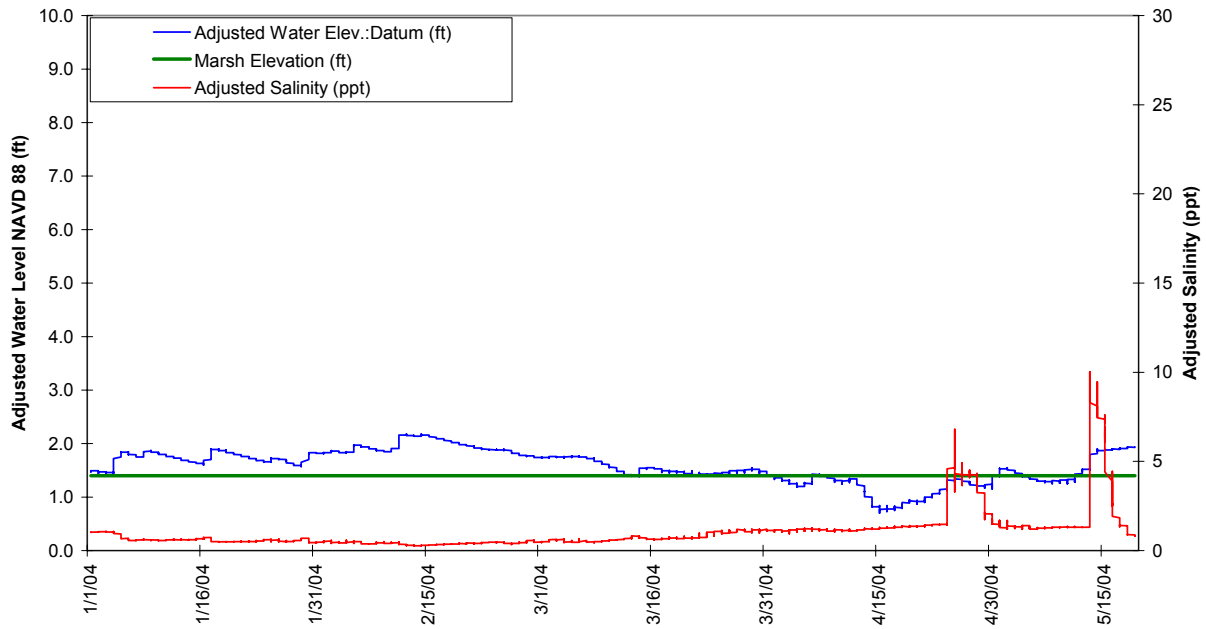
Station CS23-02 (01/01/04 – 05/19/04)
Salinity and Water Level Data

Figure 6. Hourly salinity and water level at station CS23-02 in the Sabine Structure Replacement (CS-23) project area. A water level reading above marsh elevation indicates that the marsh is flooded.

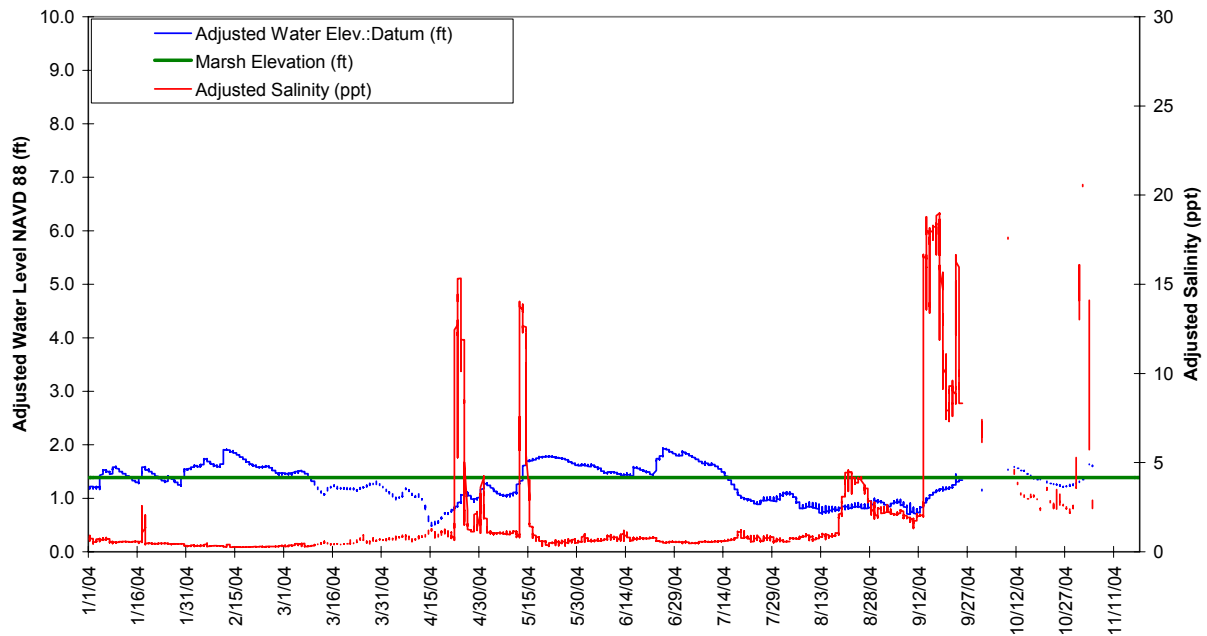
Station CS23-03 (1/1/04 – 11/18/04) **Salinity and Water Level Data**

Figure 7. Hourly salinity and water level at station CS23-03 in the Sabine Structure Replacement (CS-23) project area. A water level reading above marsh elevation indicates that the marsh is flooded.

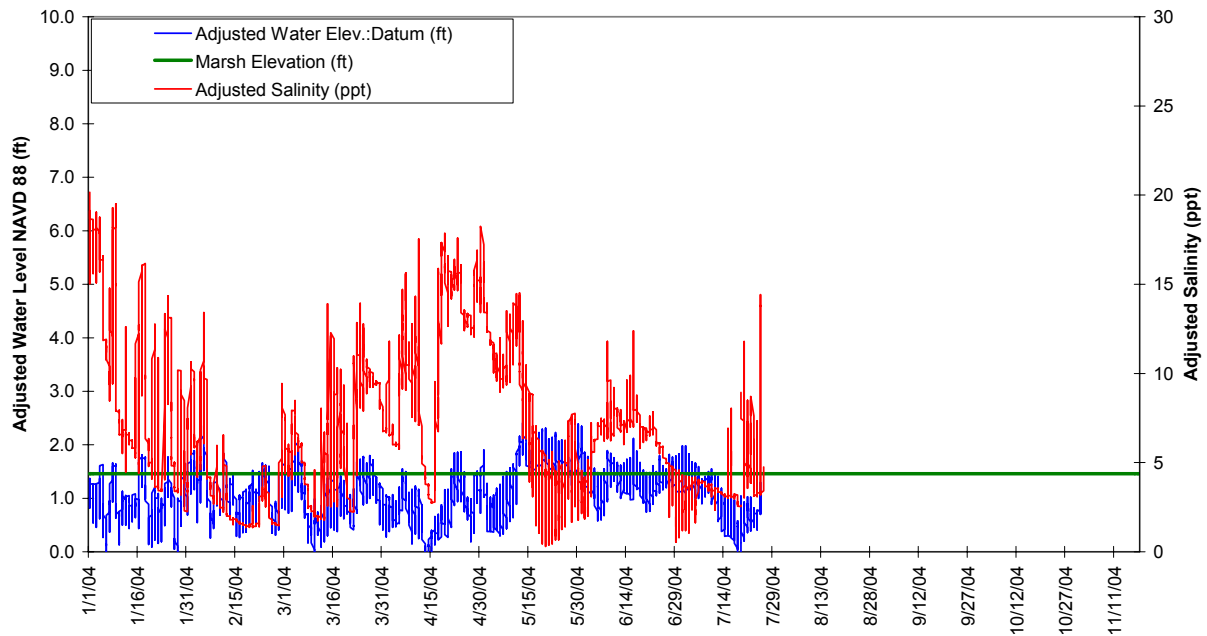
Station CS23-01R (01/01/04 – 11/18/04)
Salinity and Water Level Data

Figure 9. Hourly salinity and water level at station CS23-01R in the Sabine Structure Replacement (CS-23) project area. A water level reading above marsh elevation indicates that the marsh is flooded.

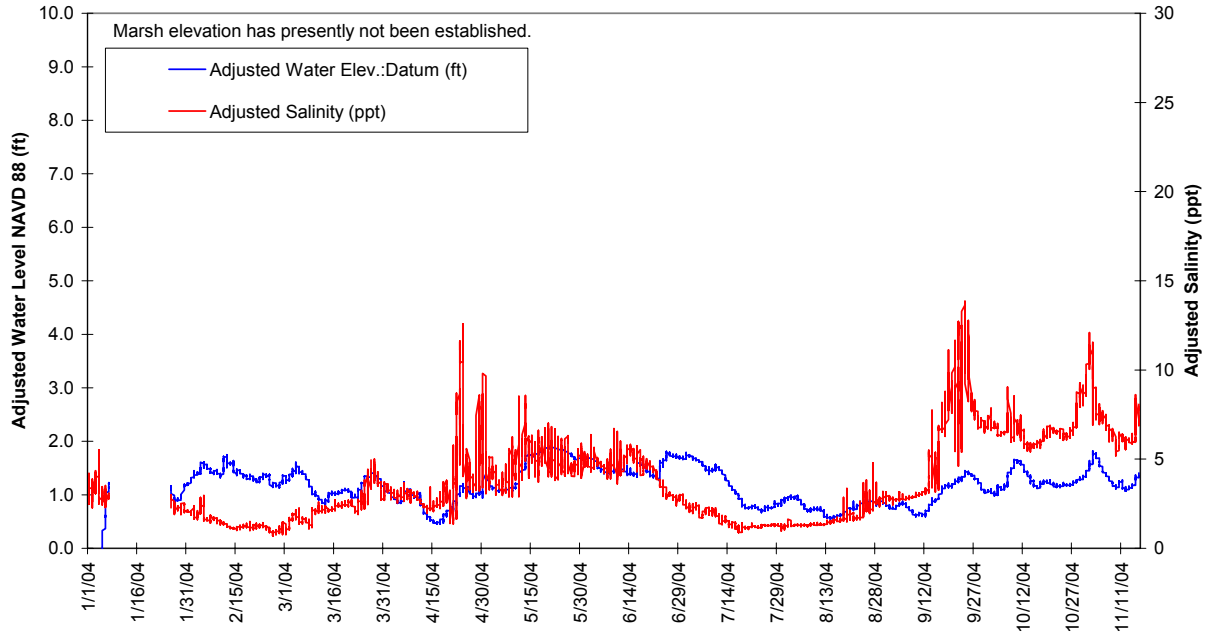
Station CS02-05 (01/01/04 – 11/16/04)
Salinity and Water Level Data

Figure 10. Hourly salinity and water level at station CS02-17 in the Sabine Structure Replacement (CS-23) project area. A water level reading above marsh elevation indicates that the marsh is flooded.

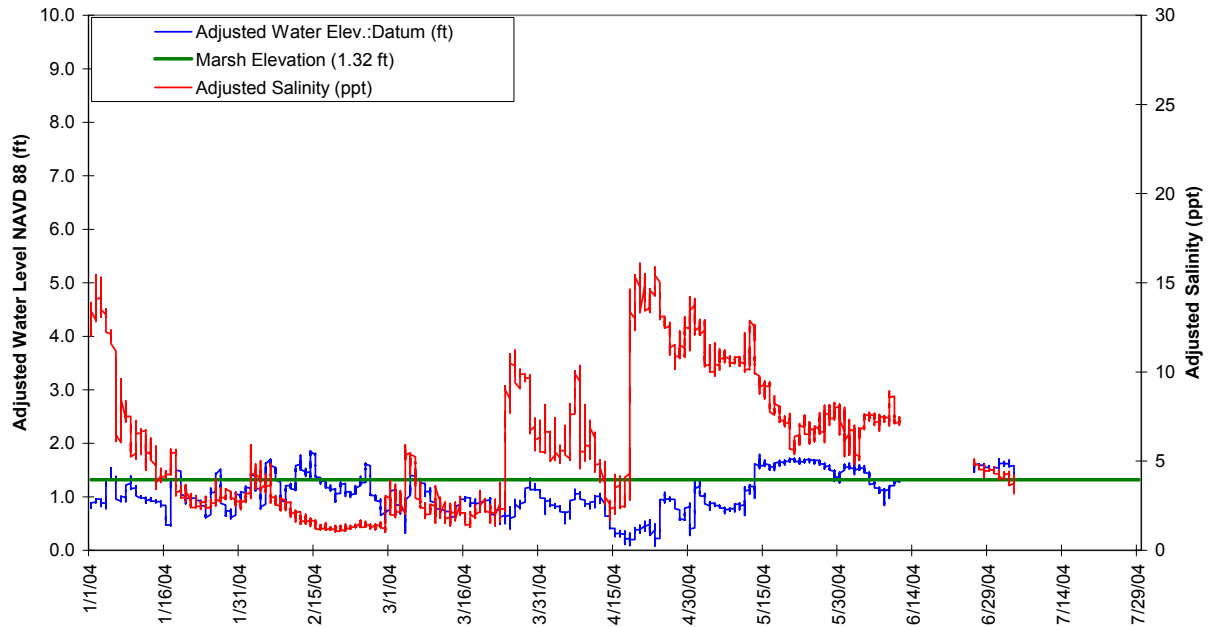
Station CS02-17 (01/01/04 – 07/30/04) **Salinity and Water Level Data**

Figure 11. Hourly salinity and water level at station CS02-17 in the Sabine Structure Replacement (CS-23) project area. A water level reading above marsh elevation indicates that the marsh is flooded.

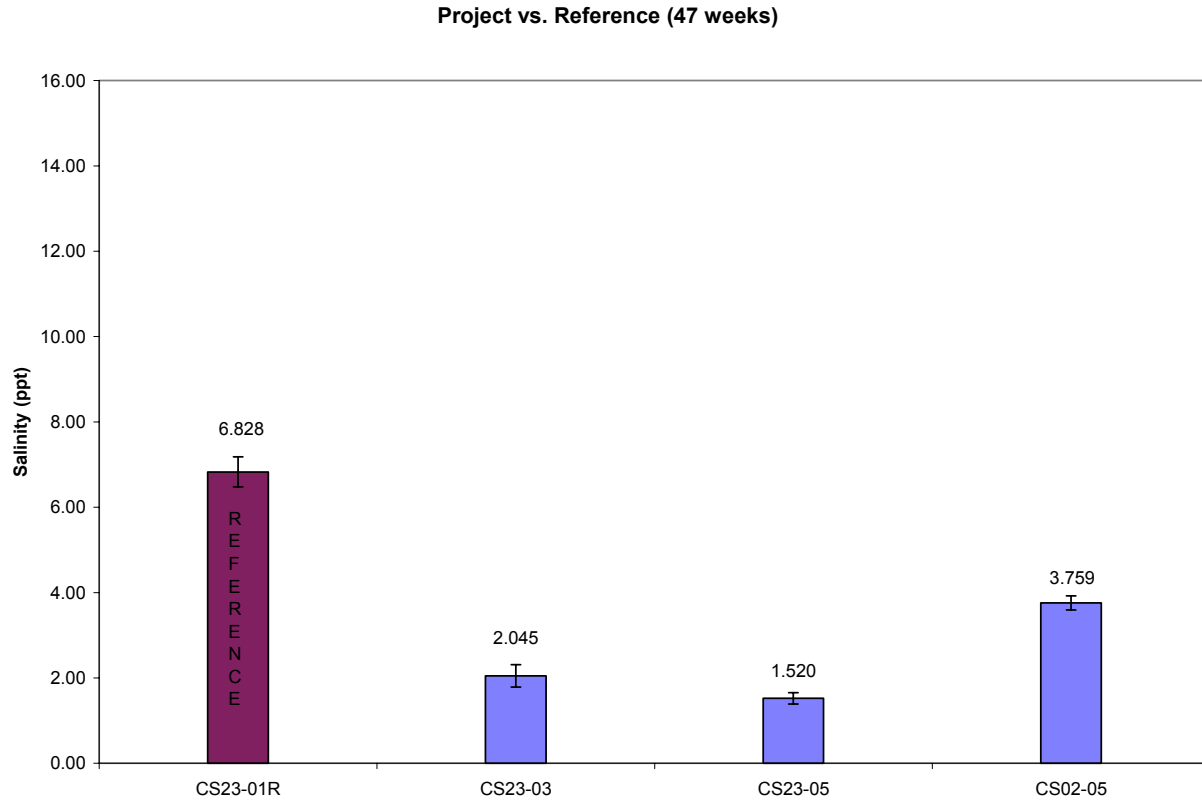
Figure 12. Yearly means derived from weekly means of salinity (ppt) at four continuous recorder stations located in the Sabine Structure Replacement (CS-23) project and reference areas for the period 01/01/04 – 11/16/04.

Hourly data were combined at each station to derive yearly mean values. Analysis of Variance (ANOVA) was conducted on yearly salinity means for 2004. Stations had significantly different salinities for 2004 ($F_{3,3} = 159.4814$; $P = 4.0001$). Post-ANOVA contrasts of each project station compared against the reference station revealed that all stations were significantly different from the reference station at the $P < 0.05$ level ($p < 0.0001$) (figure 12).

Electrical problems caused the electric motors to overheat on the Hog Island Gully and West Cove structures after the initial installation, and the structures are not fully operational at this time. Due to the inability to operate the structures correctly, salinity and water level spikes have occurred, although less frequently than during pre-construction. Yearly mean salinities derived from the weekly means were also lower within the project area when compared to the reference area (figure 12).

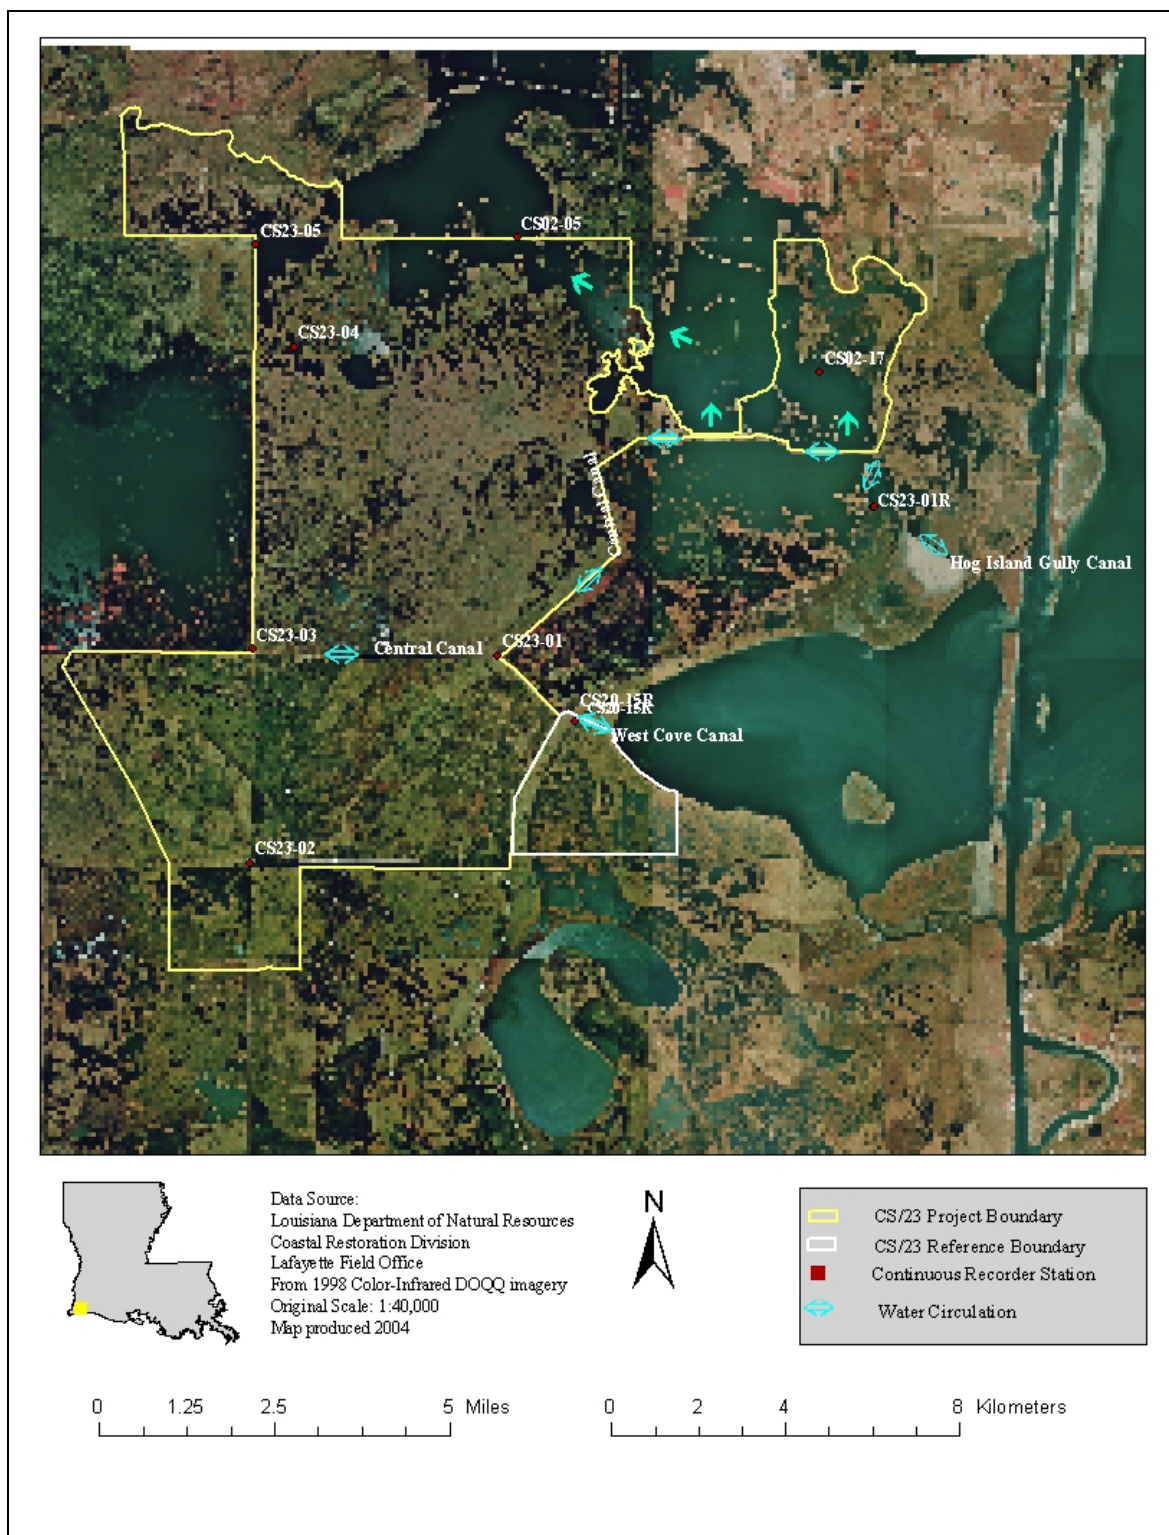
Figure 13. 1998 DOQQ imagery of continuous recorder monitoring stations and water circulation patterns in the Sabine Structure Replacement project and reference areas.

Water levels relative to marsh elevation (ft, NAVD 88) were collected hourly at four stations associated within the CS-23 project and reference areas. Water circulation patterns relative to incoming tidal flows are depicted in figure 13. Hourly data were combined at each station to derive yearly mean values. ANOVA was conducted on yearly means of adjusted water level to marsh (ft) for 2004. Stations were significantly different from each other ($F_{2,2} = 30.8$; $P < 0.0001$). Post-ANOVA contrasts revealed that both stations CS23-03 (-0.096) and CS23-05 (-0.199) were significantly different from the reference CS23-01R (-0.341) station. However, water levels relative to marsh remained below the average marsh elevation of 1.41 ft (0.43 m) for the January 1–November 26, 2004, period (figure 14).

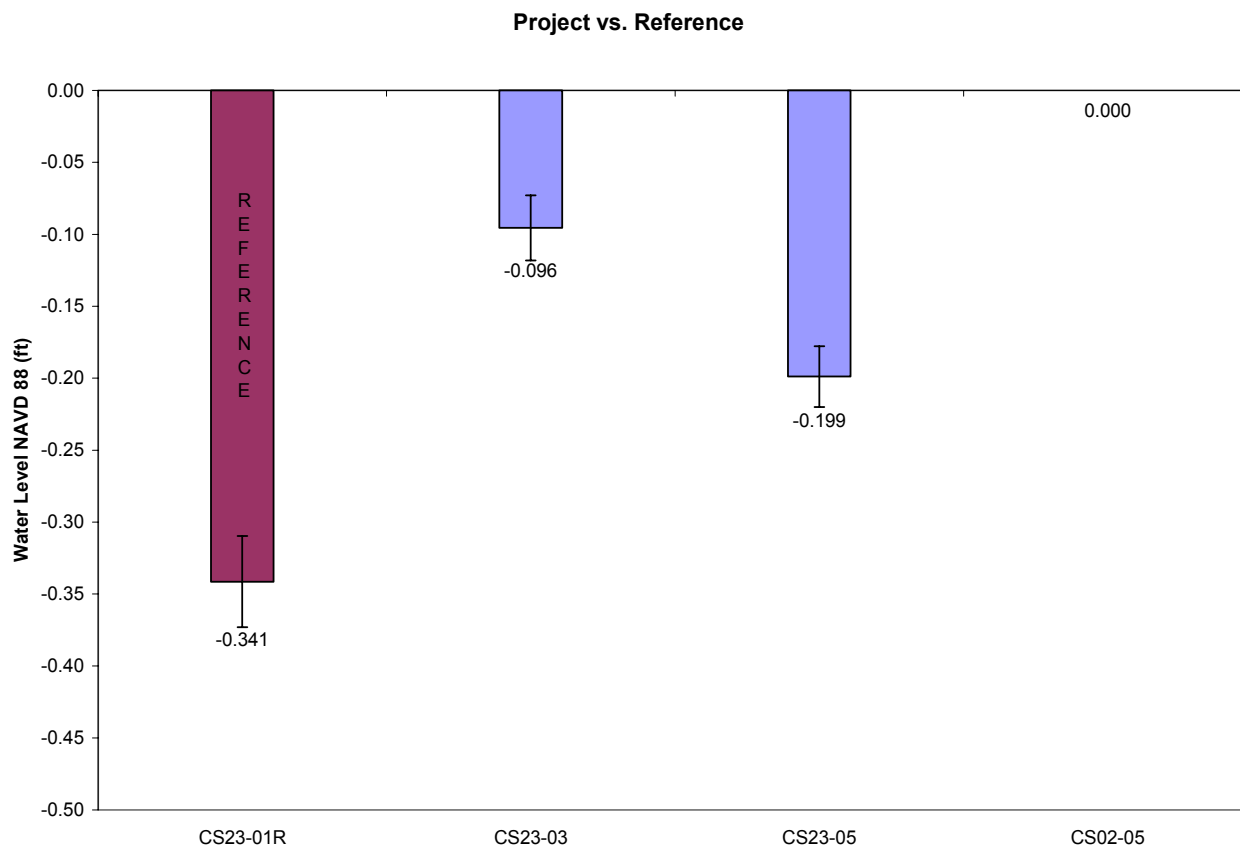
Figure 14. Yearly means derived from weekly means of water levels relative to marsh elevation (ft, NAVD 88) at four continuous recorder stations located in the Sabine Structure Replacement (CS-23) project and reference areas for the period 1/1/04 – 11/18/04.

Water levels remained below the average marsh elevation of 1.41 ft (0.43 m) for the January 1-November 18, 2004 period (figure 14).

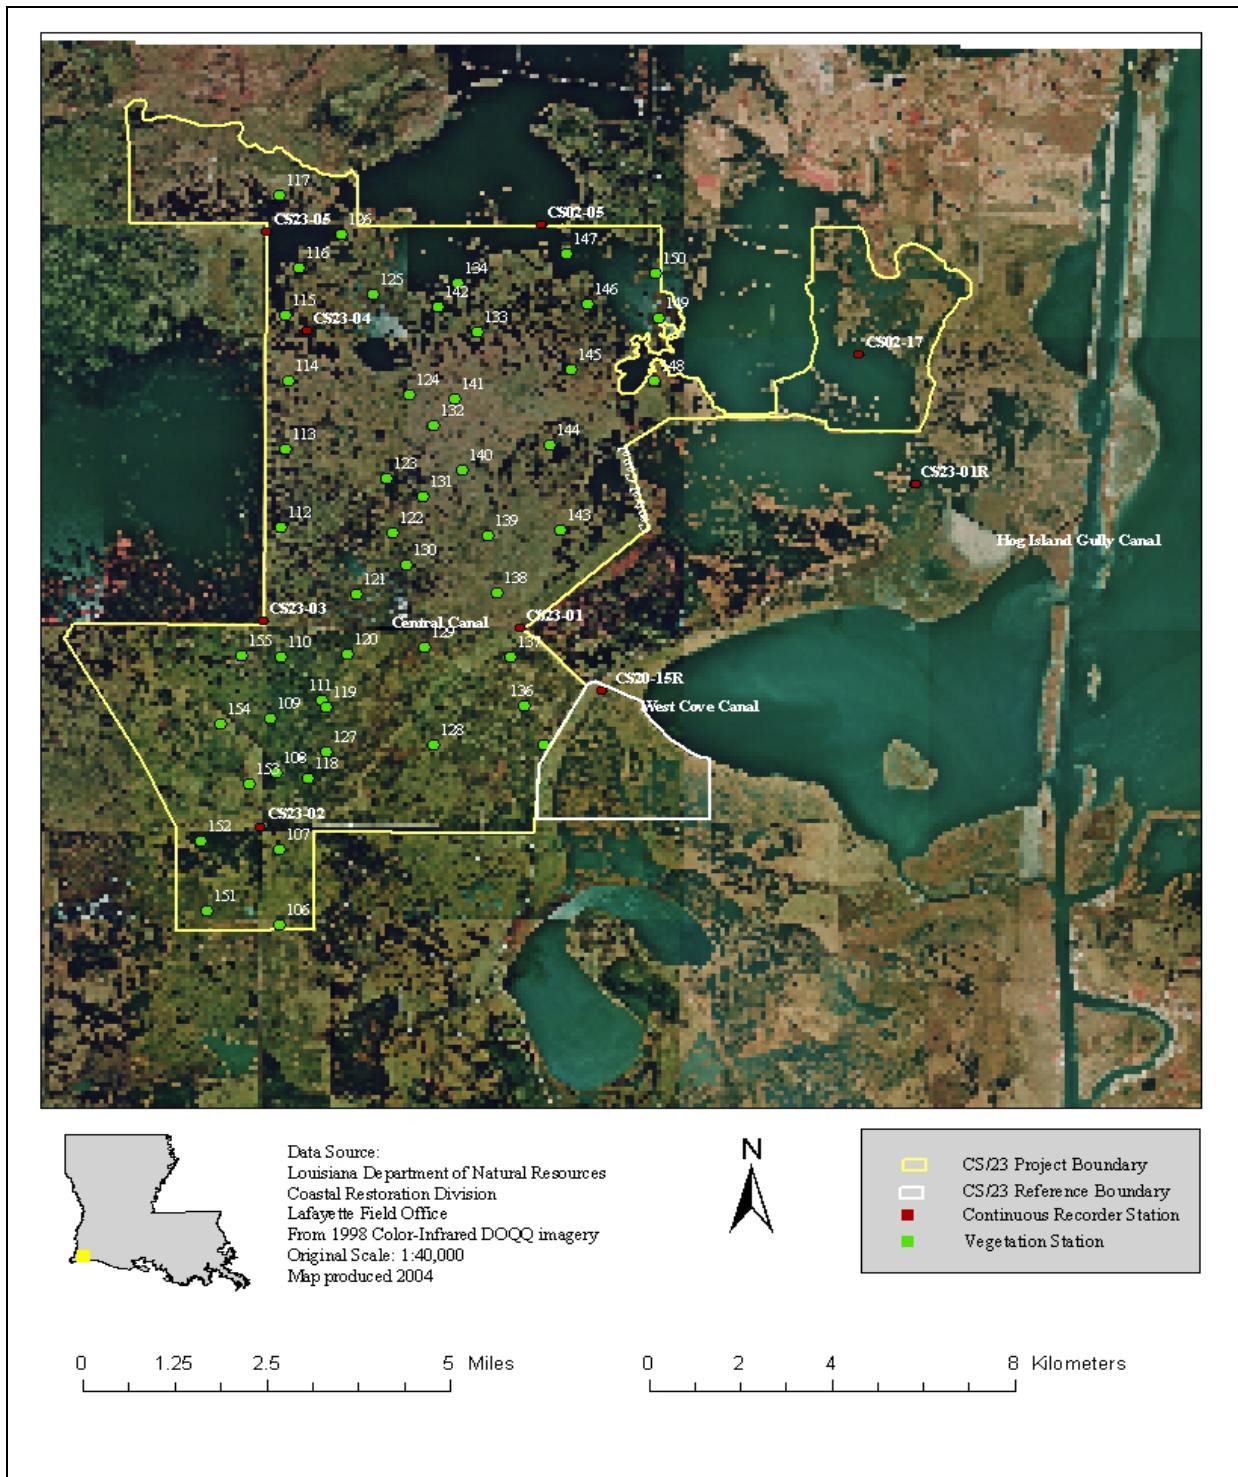
Figure 15. Location of vegetation stations within the Sabine Structure Replacement project area.

Vegetation surveys were conducted in June 2004 (N = 49 plots) during the post-construction period (figure 15). During this sampling period, the area was dominated by *Spartina patens*, which had the highest cover value of 57.1 %. The five co-dominant emergent vegetation species were *Paspalum vaginatum*, *Schoenoplectus californicus*, *Schoenoplectus robustus*, *Schoenoplectus americanus*, and *Typha latifolia*, with percent covers of 36.1 %, 32.2 %, 27.6 %, 20.4 %, and 14.1 % respectively (table 3).
